Rimkus Consulting Group, Inc.
2030 Powers Ferry Road, Suite 224
Atlanta, Georgia 30339
(770) 436-9399 Telephone
(770) 438-2189 Facsimile

December 11, 2012

Re: Claim No: 00475010651
Insured: Almassud Abdulmohsen
Subject: **Report of Findings**
RCG File No: 50802401

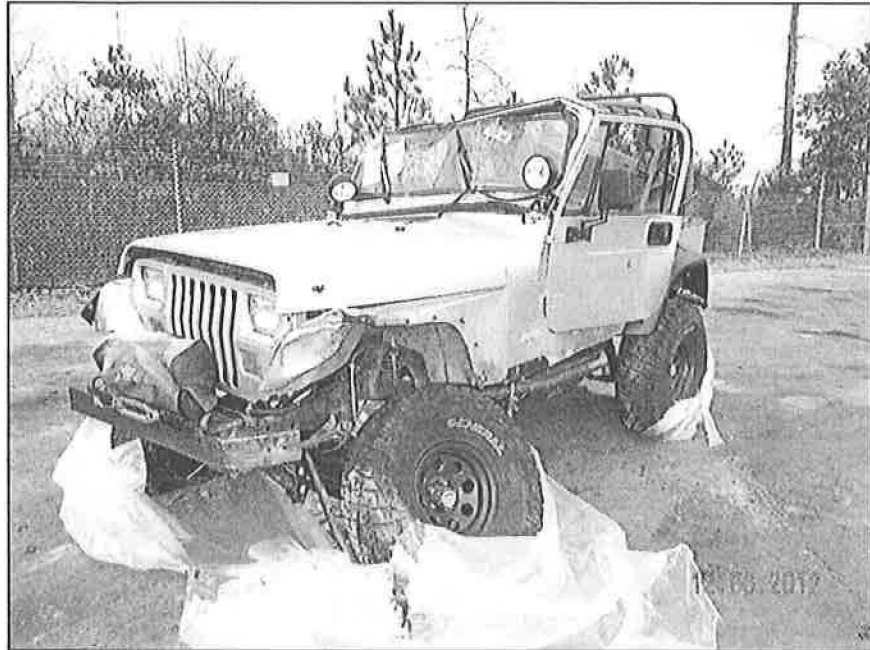
Photograph 1
The 1995 Jeep Wrangler.

On December 6, 2012, the 1995 Jeep Wrangler was inspected and photographed at the IAA facility in Loganville, Georgia (**Photograph 1**). The Jeep vehicle identification number (VIN) was 1J4FY19P7SP307355. The most severe impact damage was inflicted to the left-front portion of the Jeep. The left-front wheel was bent with the top of the tire and wheel leaning inward.

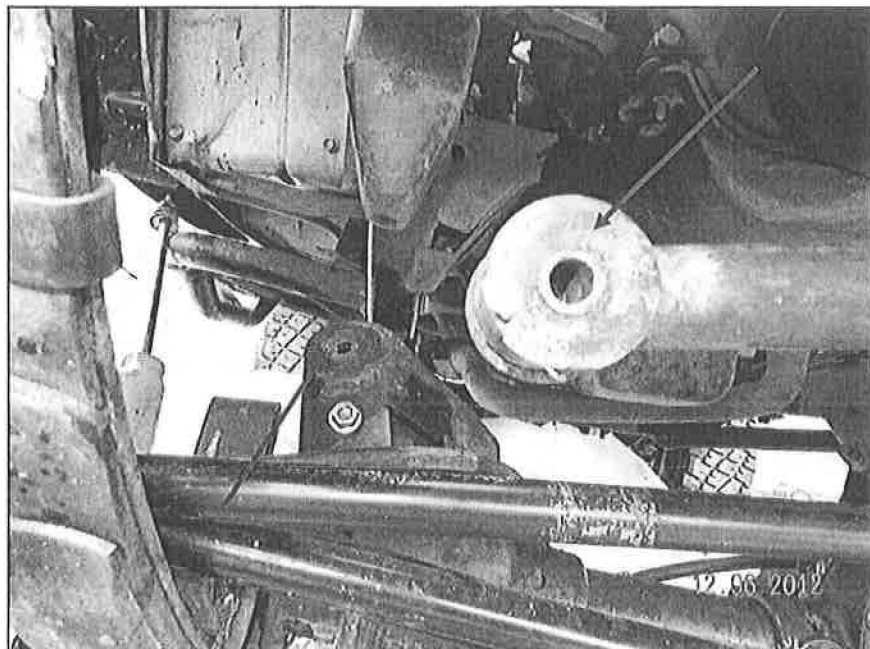
Photograph 2
The bracket (red arrow) and right end of the front track bar (blue arrow).

The right and left forward leaf spring brackets for the front axle were broken and separated from the right and left frame rails. The front track bar was separated from the bracket at the axle end of the track bar (**Photograph 2**).

The bolt and nut that secured the track bar to the axle-end bracket were missing and not available for examination. The left center link (drag link) end bracket at the left steering knuckle broke and separated from the left steering knuckle (**Photograph 3**). The center link left end remained attached to the broken portion of the steering knuckle with the crown nut and cotter pin still intact (**Photograph 4**). The right-center link end remained attached to the right steering knuckle with the crown nut and cotter pin still in place.

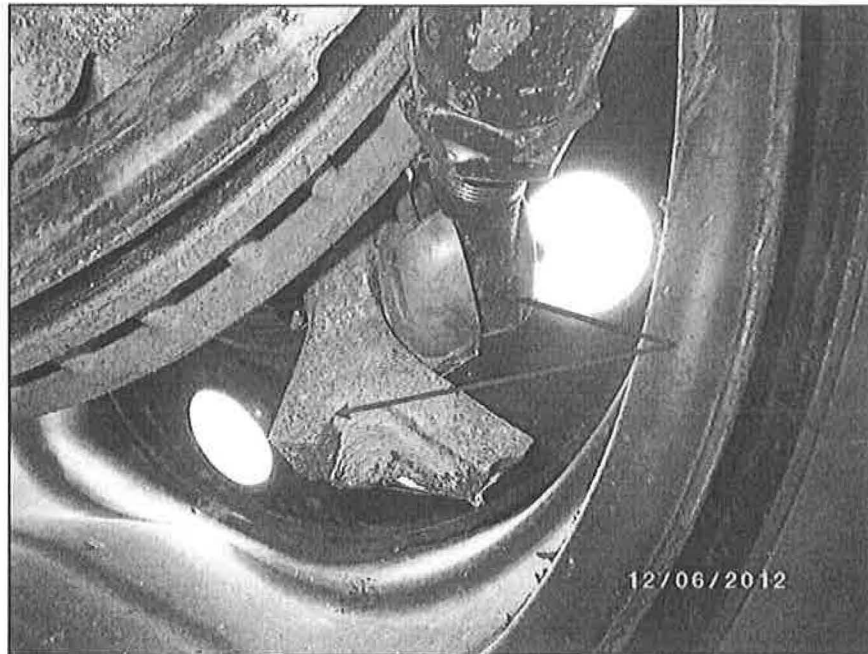
Photograph 3

The broken left steering knuckle and left end of the center link (with crown nut and cotter pin in place).

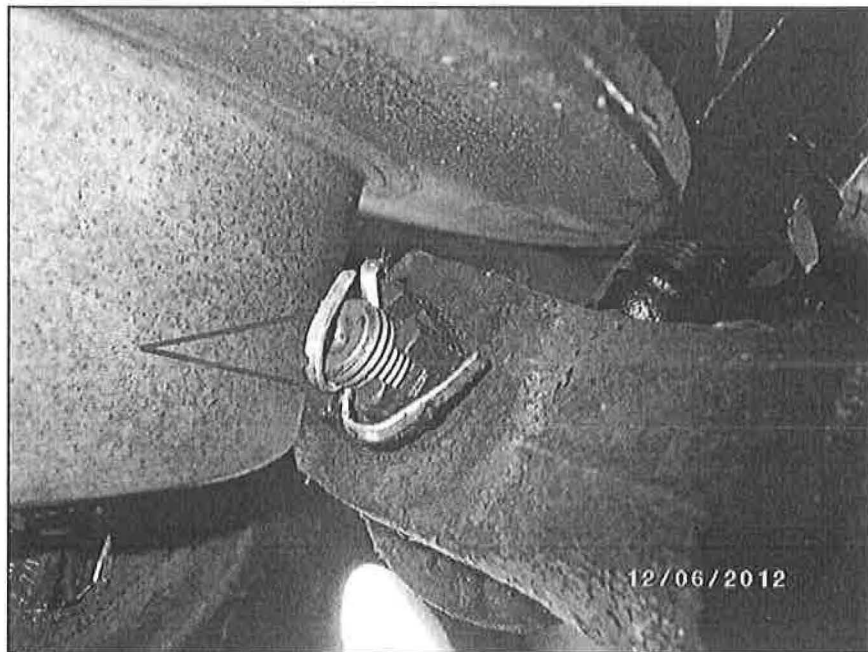
Photograph 4

The crown nut and cotter pin on the left end of the center link.

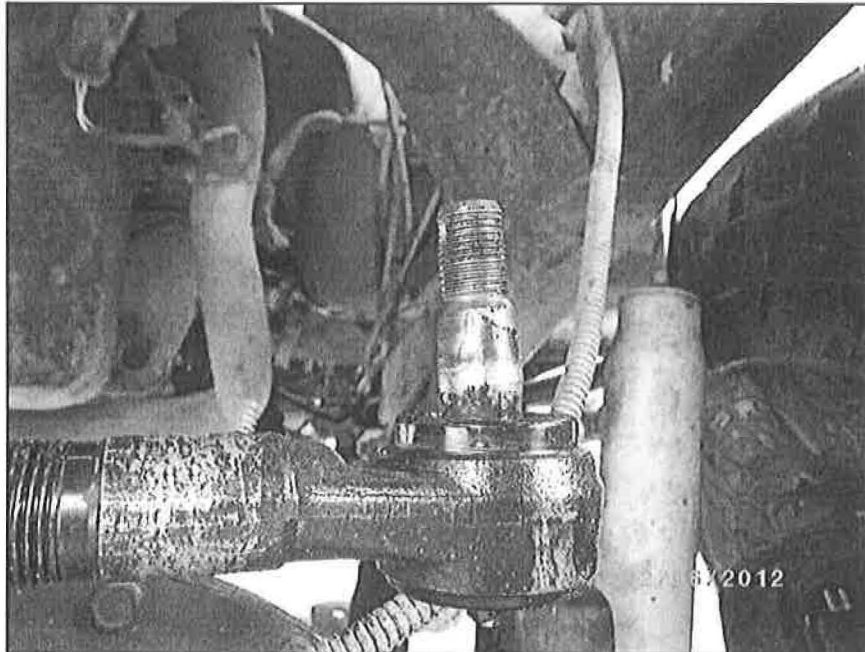
Photograph 5

1. The conditions of the drag link and pitman arm on the Jeep were consistent with one end of the drag link having separated from the pitman arm as a result of an installation error.
2. The cotter pin utilized to prevent the crown nut from loosening was either never installed, or installed improperly allowing it to separate from the tie rod end and subsequently allowing the crown nut to loosen and separate from the tie rod end resulting in the tie rod separation from the pitman arm.

The right tie rod end (connected to the right end of the center link) remained attached to the center link with the crown nut and cotter pin in place. The left tie rod end separated from the pitman arm (**Photographs 5 and 6**). The crown nut and cotter pin for the left tie rod end were missing and were not available for inspection.

The condition of the male threaded end of the left tie rod end was consistent with the crown nut loosening due to the absence of a cotter pin to prevent crown nut rotation. There were no damages to the left tie rod end or pitman arm that were caused by the subject collision. The conditions of the pitman arm and the left tie rod end are consistent with a separation that occurred prior to the collision as reported by the driver of the Jeep.

The left tie rod end that separated from the pitman arm.

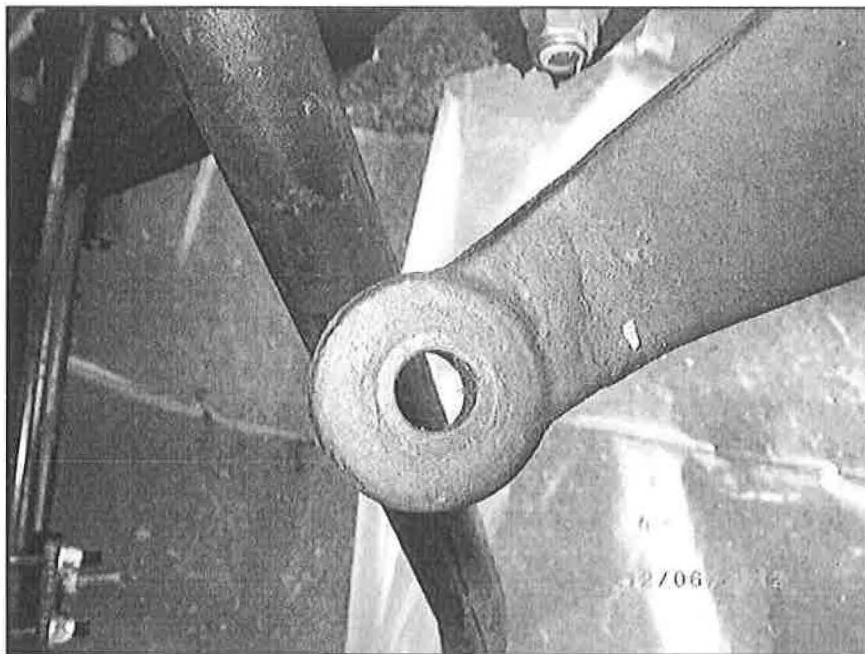
Photograph 6

The tie rod connection end of the pitman arm.
